UNITED STATES ARMY AVIATION BOARD
Fort Rucker, Alabama

REPORT OF TEST

PROJECT NO. AVN 1162

EVALUATION OF RYANAV IV DOPPLER NAVIGATION
SYSTEM

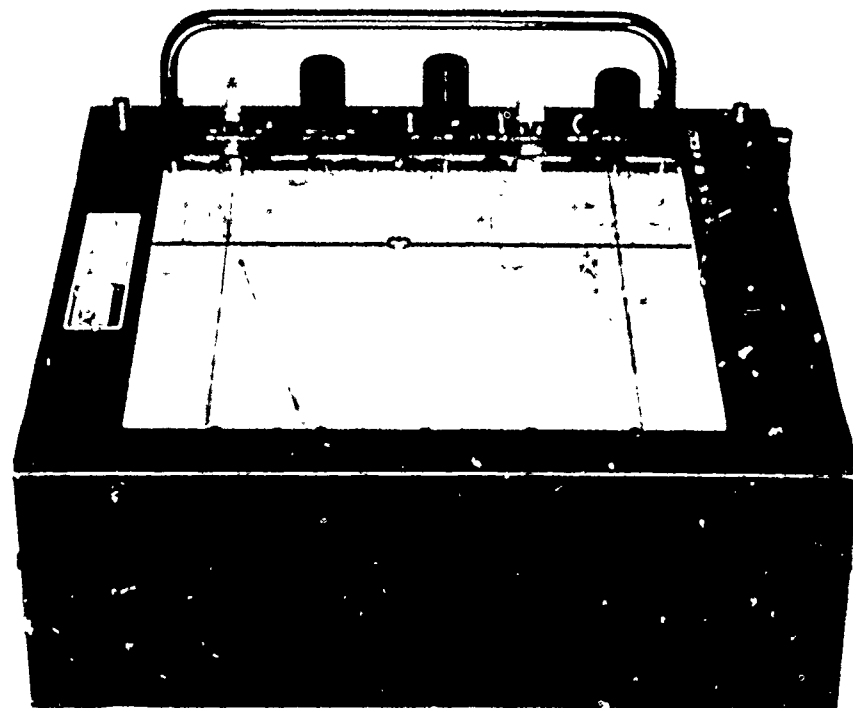
Figure 3. AFC plotting board

(2) The plotting board (see figure 3) had limited application in this configuration. Templates used in the plotting board covered 40-nautical-mile square areas for charts of 1/500,000 and 80-nautical-mile square for charts of 1/1,000,000. At an average airspeed of 140 knots on a generally straight-line mission, it was necessary to change templates every 17 minutes for the 1/500,000 charts and every 34 minutes for the 1/1,000,000 charts.

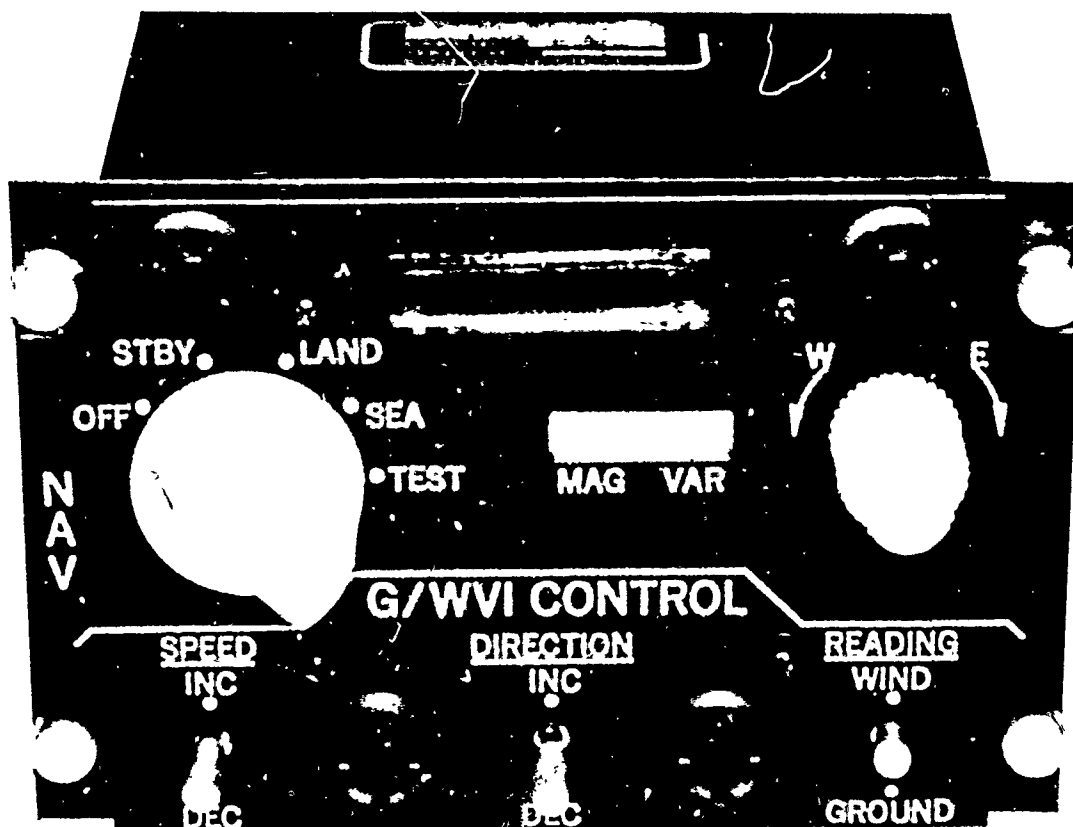
Figure 8. The G/WVI control

(1) The G/WVI control (figure 8) was easy to operate in that the switches and control knobs were readily available and lettering was easily readable. The two switches controlling wind speed and direction and the switch controlling the wind/ground reading seemed fragile. At one time one of the switches was bent, but still usable. No failures occurred during the evaluation.

<u>SHORTCOMINGS</u>	<u>SUGGESTED COR- RECTIVE ACTION</u>	<u>REMARKS</u>
The three toggle switches on the G/WVI control are too fragile.	Install more rugged switches.
